**NORTH RIVER BASIN
PEABODY, MASSACHUSETTS**

**SPRING POND DAM
MA 00193**

**PHASE 1 INSPECTION REPORT
NATIONAL DAM INSPECTION PROGRAM**

DECEMBER 1978

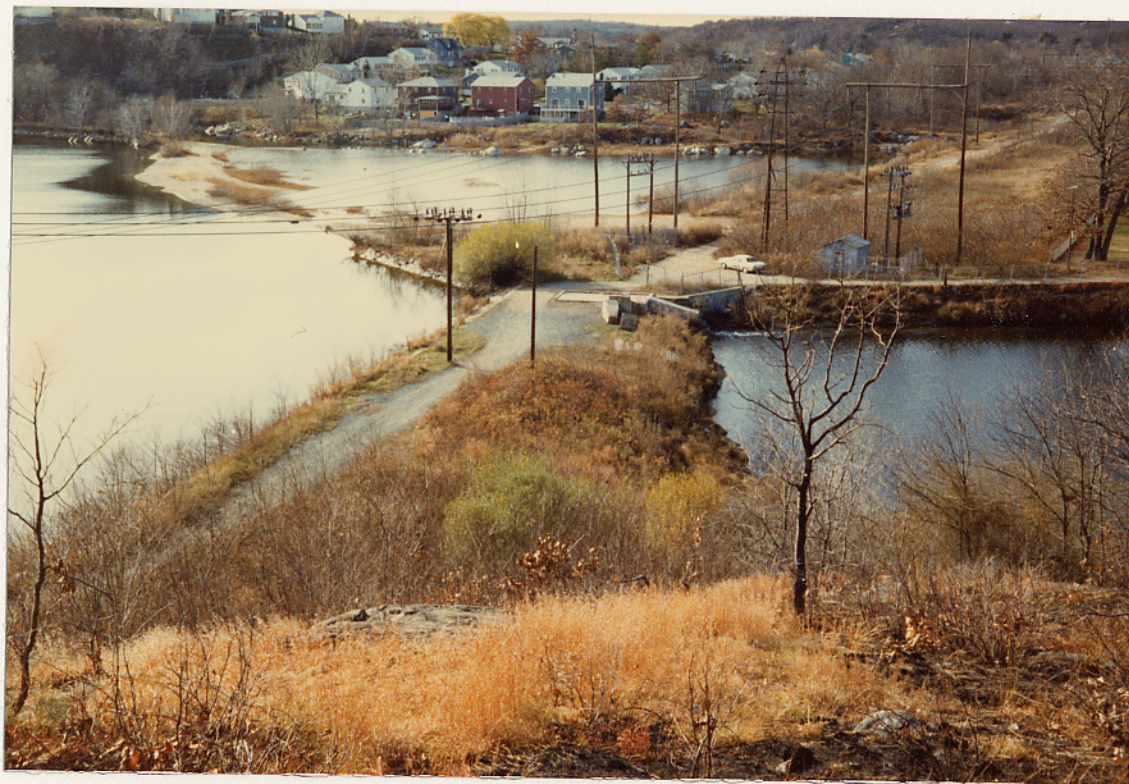
1. GENERAL OVERVIEW OF DAM.

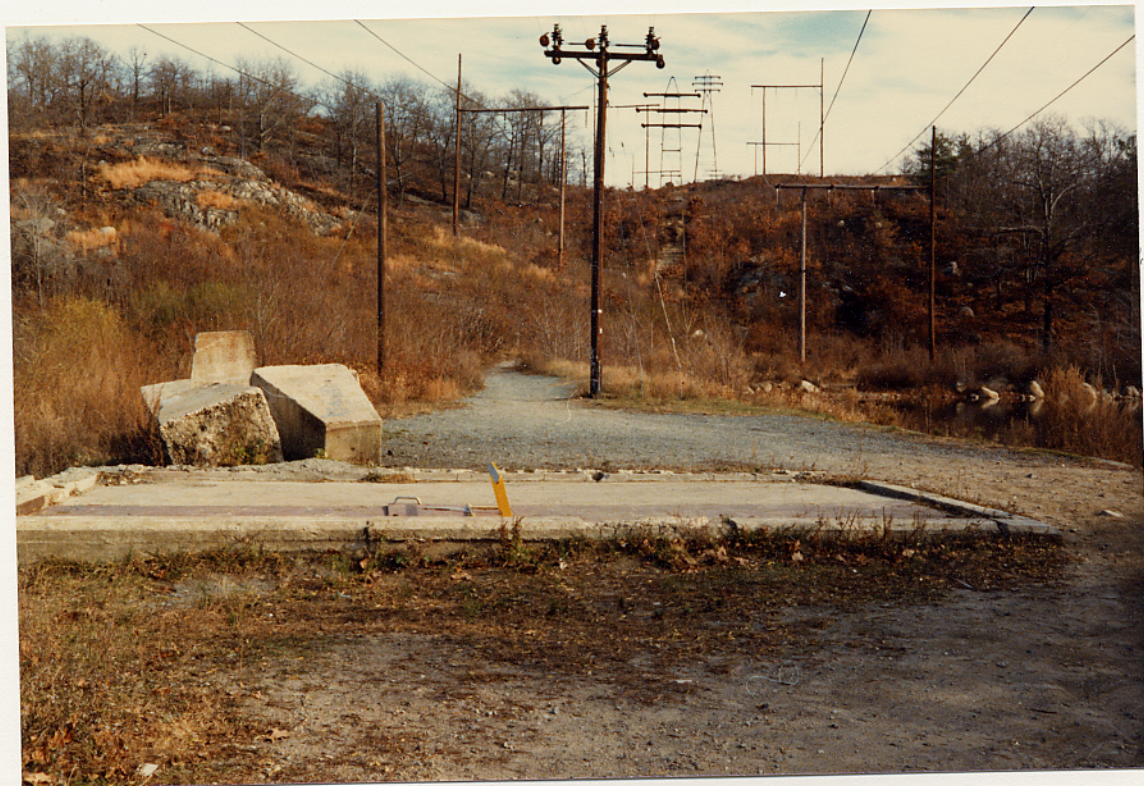
The earth embankment appears to be in generally good condition. The horizontal alignment of the crest is generally good and the vertical alignment is also good except for some depressions and ruts which have been created by traffic, especially trail bikes. (See Photograph No. 2). There is a high voltage transmission tower and a telephone pole located on the crest of the embankment. (See Photograph No. 2). Several concrete blocks were observed on the crest. It is reported that these will be placed, at some future date, on the upstream slope as additional slope protection. (See Photograph No. 2).

2. VIEW OF CREST. NOTE REMNANT OF GATE HOUSE IN FOREGROUND AND HIGH VOLTAGE TRANSMISSION TOWERS.

5. Remove all brush, shrubs and young saplings from both slopes and the crest.
6. Refill areas of erosion and gullies on the downstream slope and crest.
7. Replace stones missing on upstream riprap slope protection.
8. Traffic on the crest should be eliminated. If this is not practical, consideration should be given to paving the crest.
9. Consideration should be given to relocating the high voltage transmission tower off the dam crest.

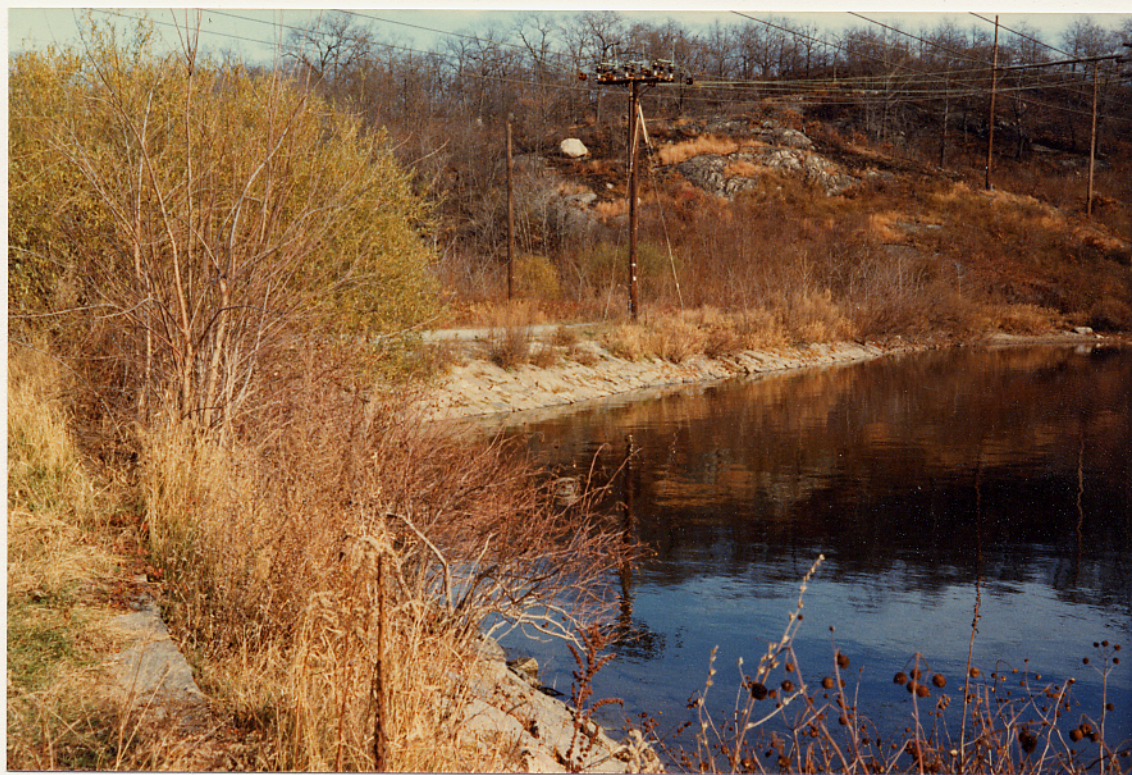
The upstream slope is in generally good condition. The cemented riprap is in good condition, however, the cemented section of riprap extends only little more than half way along the length of the embankment. The remainder of the slope protection consists of uncemented riprap. In this area some stone is missing, and others have been displaced. There are saplings, tall weeds, brush and grass growing through the riprap. (See Photograph No. 3). Two 8-inch diameter pipes located on either side of and parallel to the spillway and about one foot below the dam crest were observed. Reportedly these pipes had been used as overflow pipes but have since been plugged.

Rock Slope Protection - Riprap Failures upstream slope - uncemented portion of riprap shows some displaced and missing stones. (See Misc. Comments)

3. VIEW OF UPSTREAM SLOPE. NOTE CEMENTED STONE RIPRAP AND VEGETATION.

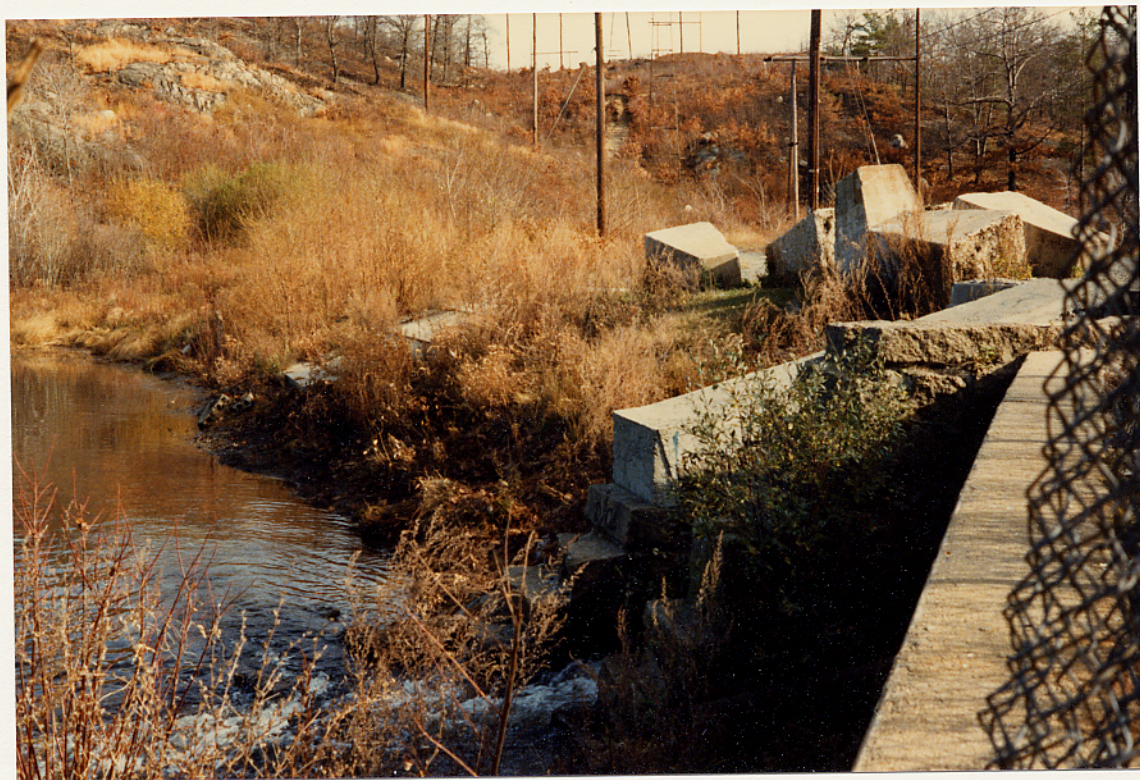
The downstream slope is in generally good condition except that there are several gullies, probably caused by run-off and/or pedestrian traffic. The surface of the slope is overgrown with numerous saplings, tall grass and bramble bushes. Several concrete slabs about 10 feet long and 12 inches wide, reportedly remnants of the old gatehouse roof, have been placed on the slope. (See Photograph No. 4).

There are several gullies, probably caused by run-off and/or pedestrian traffic on downstream slope.

4. VIEW OF DOWNSTREAM SLOPE. NOTE VEGETATION.

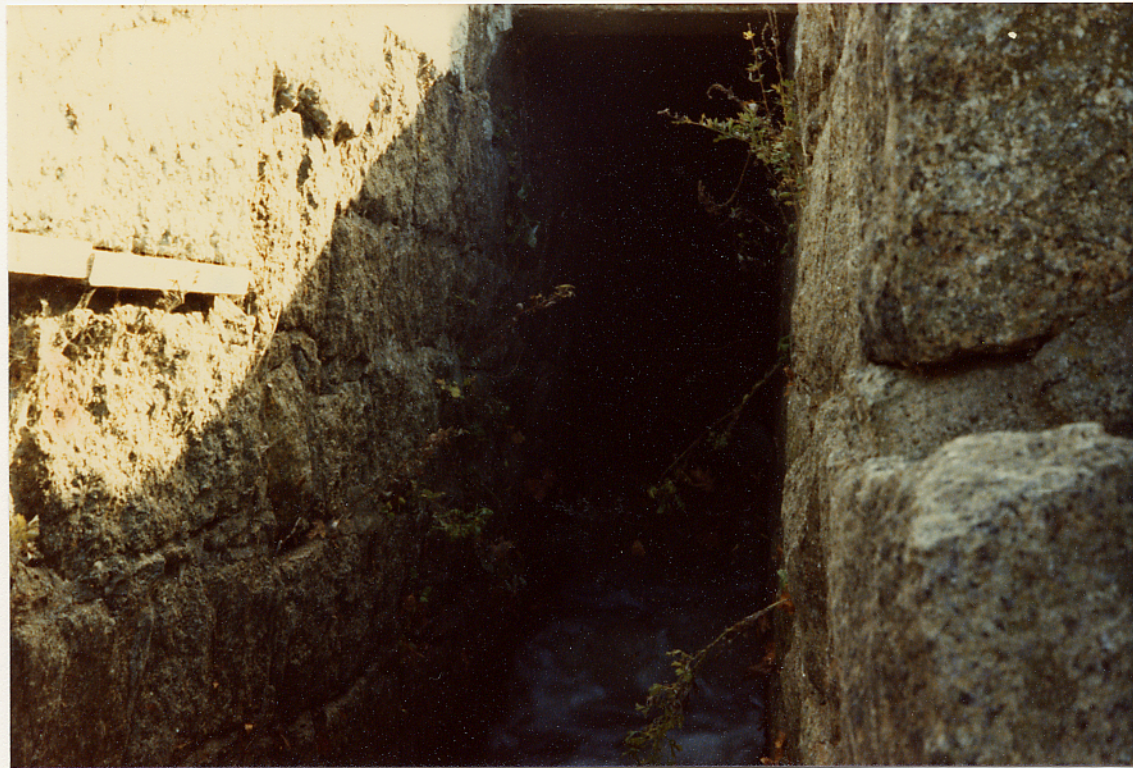
The outlet-spillway is in generally good condition. The stone masonry training walls are in good condition with only minimal growth of vegetation through the stones. (See Photograph No. 5). The right wall is capped with about six

5. VIEW OF SPILLWAY LOOKING UPSTREAM.
